RARITAN RIVER BASIN

FARRINGTON DAM

PHASE I INSPECTION REPORT NATIONAL DAM SAFETY PROGRAM

NJ 00383

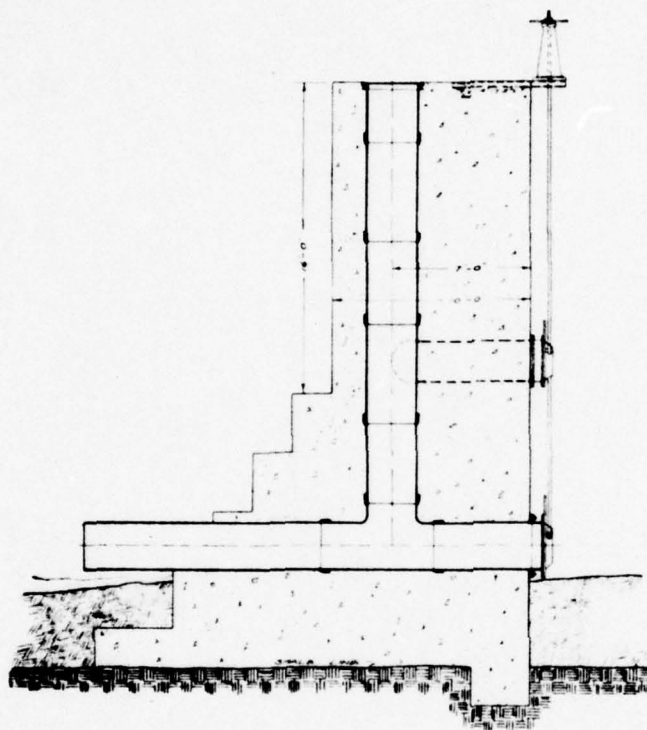
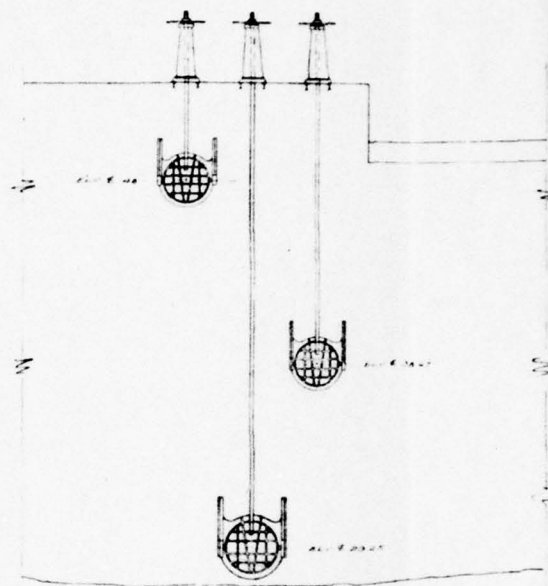
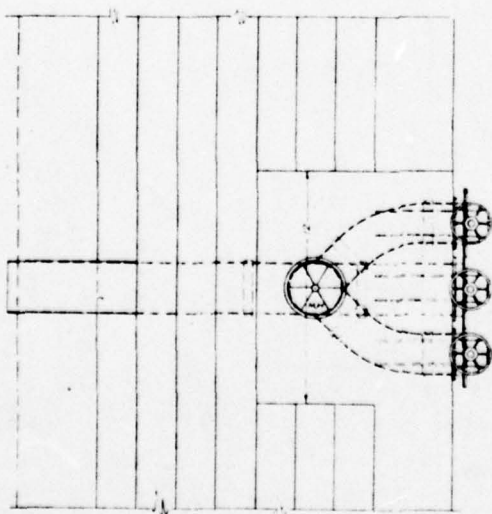
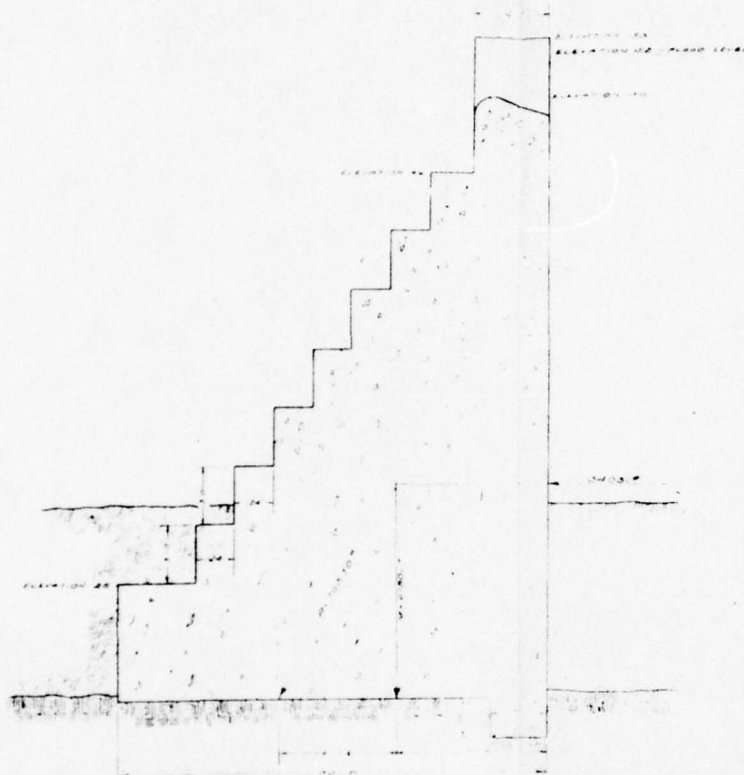
DWG. NO. 3

FARRINGTON DAM
FOR THE
CITY OF NEW BRUNSWICK
DETAILS OF SLUICE GATES-CROSS SECTION
SHEET NO. 3
SCALE 1/2" = 1'-0"

The rehabilitation of the deteriorated dam spillway crest and facing would be part of such a plan. The low and high level outlet gates should be brought up to full operational capacity within six months.
